Giant Garter Snake Habitat Evaluation Survey

PREPARED FOR: EJ Koford/CH2M HILL
PREPARED BY: Richard Crowe/CH2M HILL
COPIES: Russell Huddleston/CH2M HILL
DATE: October 4, 2002; Revised March 21, 2003

The Sacramento Municipal Utility District (SMUD) proposes to develop a natural gas-fired generating facility south of the Rancho Seco Plant in Sacramento County, 25 miles southeast of the city of Sacramento. It will be a high-efficiency, combined cycle facility that will provide electricity to SMUD's Customers. As part of the Cosumnes Power Plant (CPP) project, a new 24-inch pipeline will be constructed from Carson Cogen Facility, approximately 20 miles northwest of the CPP. The natural gas supply line will be constructed using open-trench, jack and bore and horizontal directional drilling techniques. The construction corridor is estimated to be 65 feet wide in most areas, but will be reduced to 35 feet where limited by environmentally significant features.

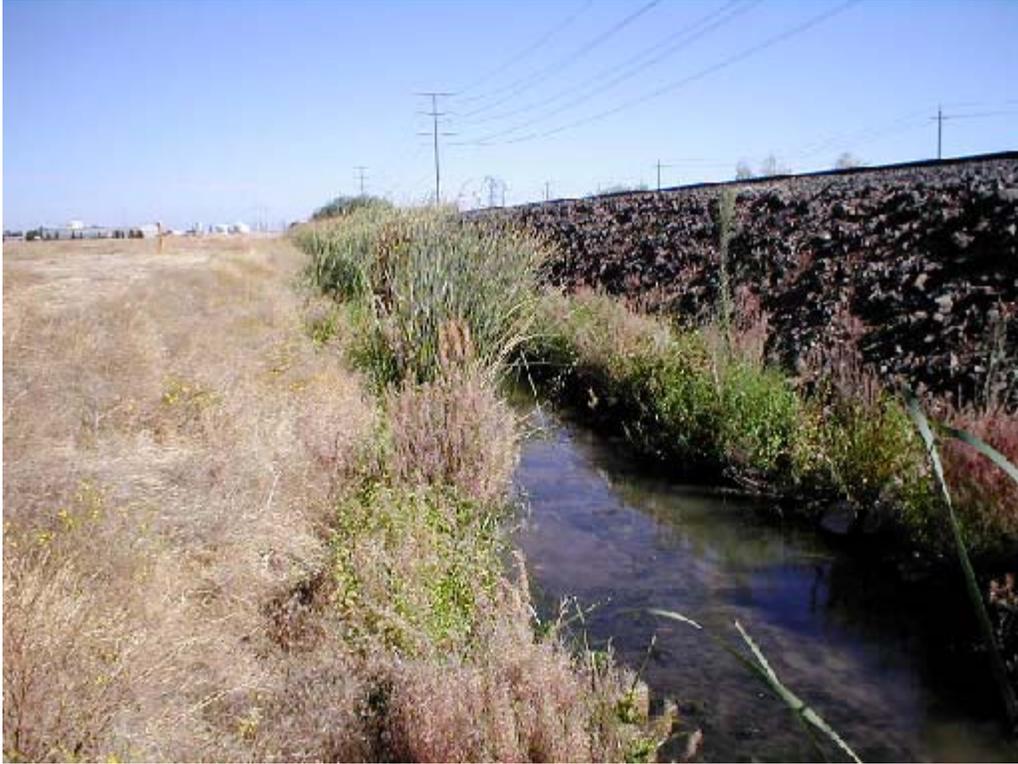
GGG Site #1 September 5, 2002

1 Photo taken site has intermittent thick stands of #33 cattails, some open water. Water depth was 5-7" Ditch is located just North of Sims Road within County Regional Sanitation District (Bufferlands)

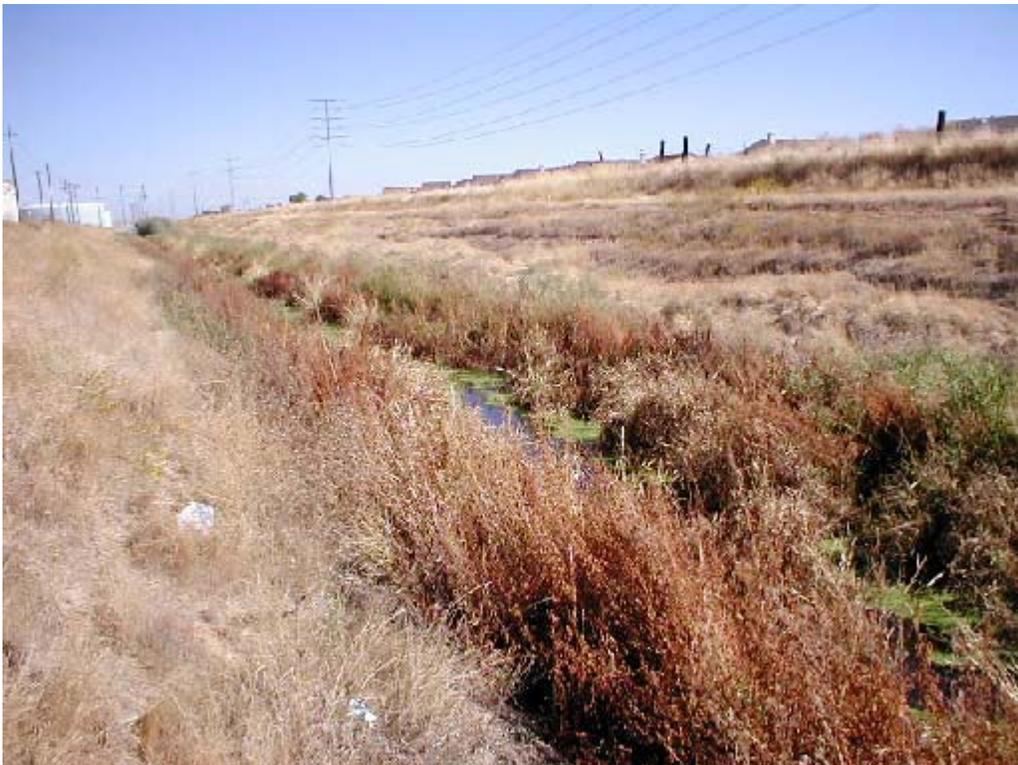
GGG Site #2 September 5, 2002

Notes and Comments (attached additional pages if necessary):
Photo taken 2/6 canal 12-15' wide, emergent veg present
small willow patch @ north end on east side of bank
water smartweed, ditch is adjacent to lg. detention basin
situated between housing to the east and warehouses to
the west.

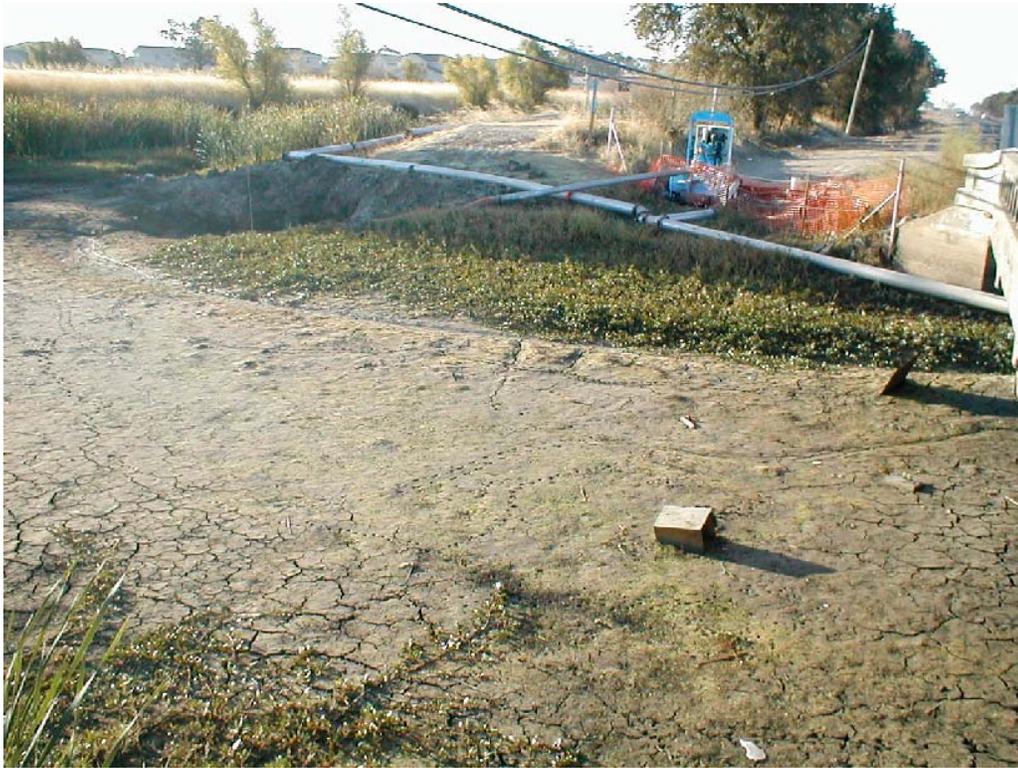
GGs# 3 October 3, 2002.

1 photo, Franklin Area is presently being disturbed
for development of Franklin Meadows. Prg @ time
of survey

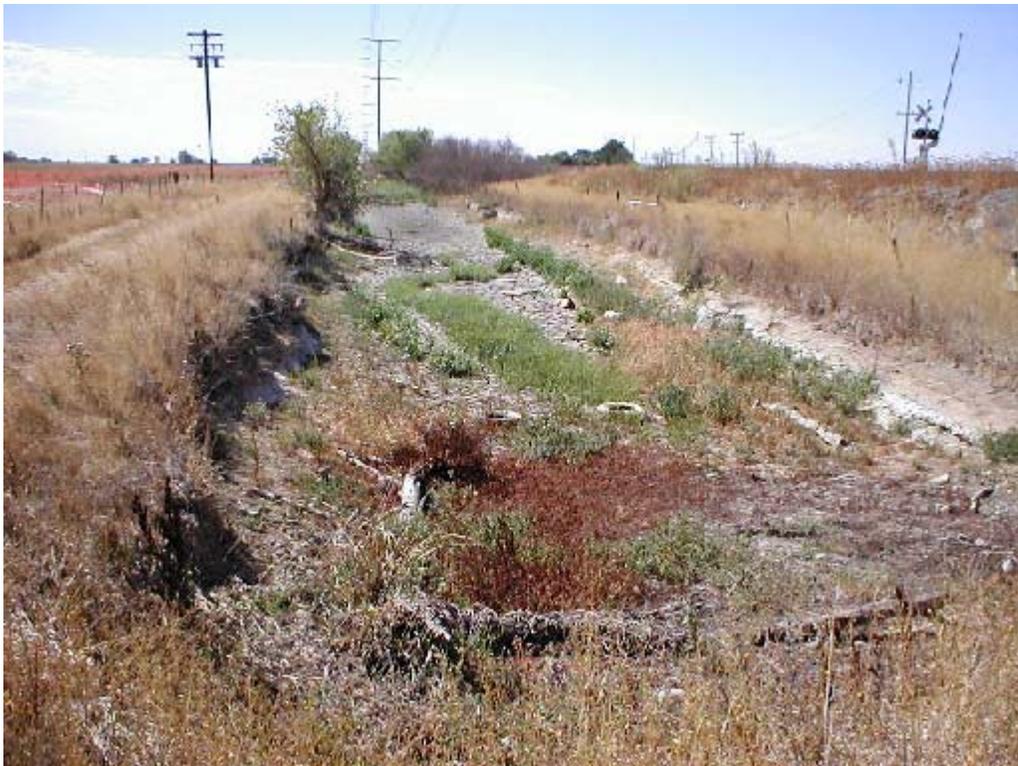
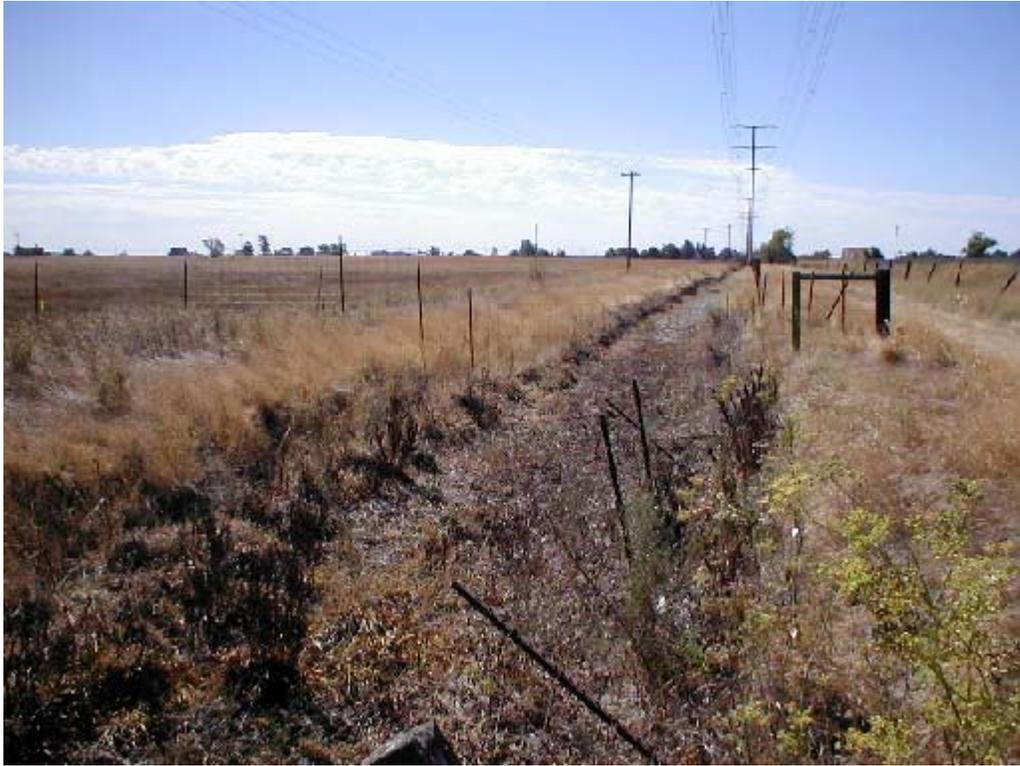
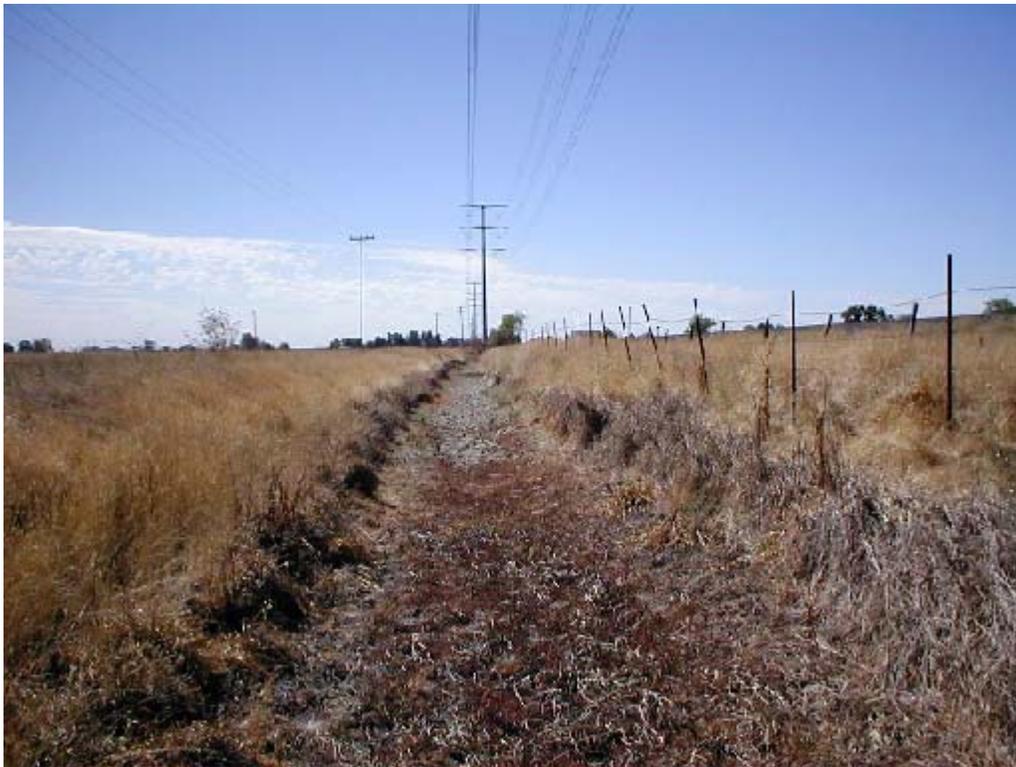
GGs Site #4A September 5, 2002

3 Site is Ag tailing pond, dry during time of survey
Photostaker. Observed SWMA @ this location
~~37+38+37~~ pond is located between road to the east and new housing development to the east. Tailing pond w/associated irrigation ditches all areas dry @ time of survey
